Woodburn POTW – Process Mechanical Assessment

PREPARED FOR: City of Woodburn Wastewater Facilities Plan
PREPARED BY: Michelle Burkhart/CH2M HILL
REVIEWED BY: Dave Green/CH2M HILL
DATE: May 20, 2008
PROJECT NO.: 367677.FP.03

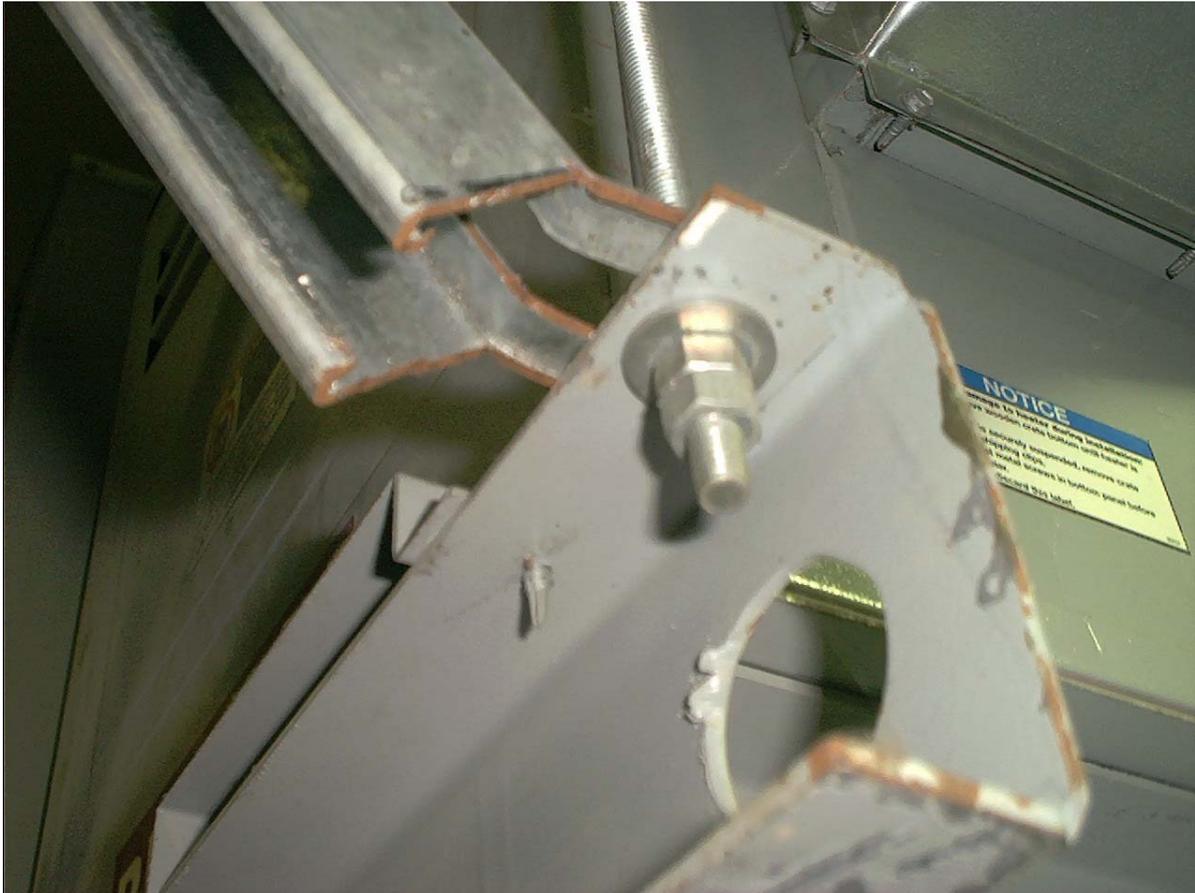
Site Visit 3 26 08 011.jpg

This facility was remodeled in 2001. The building is a one-story masonry building with CMU walls and brick veneer, a gypboard ceiling, and composition shingle roof. Due to the gypboard ceiling, no details of the roof framing could be observed. The drawings for the remodeling appear to indicate that the roof framing is wood trusses. Piping and conduits in the main room appear to be well braced, except that as shown in one photo, the bracing was connected through a longitudinally slotted hole rather than through the hinged connection piece normally used. It appears that only the friction created by tension in the bolt is available to resist lateral load. No bracing of tall electrical equipment in the separate room was observed.

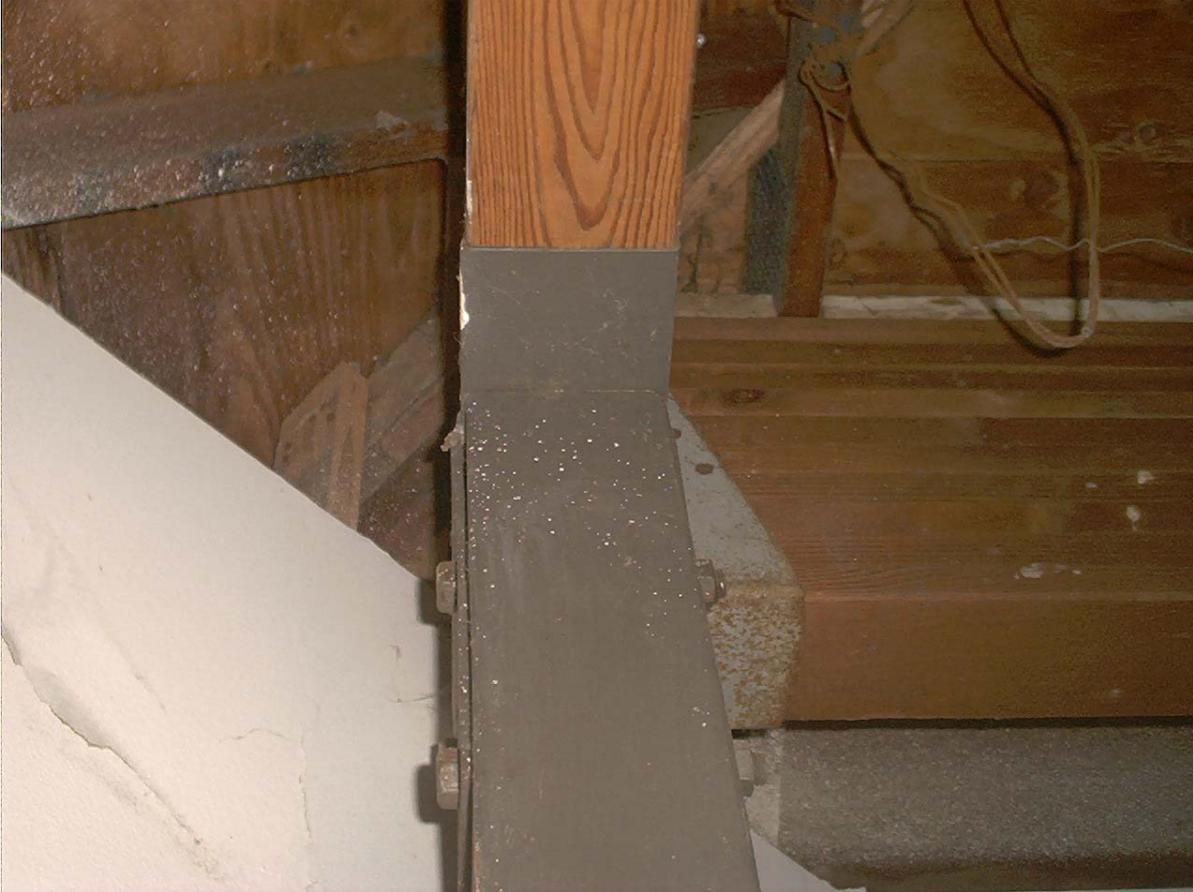
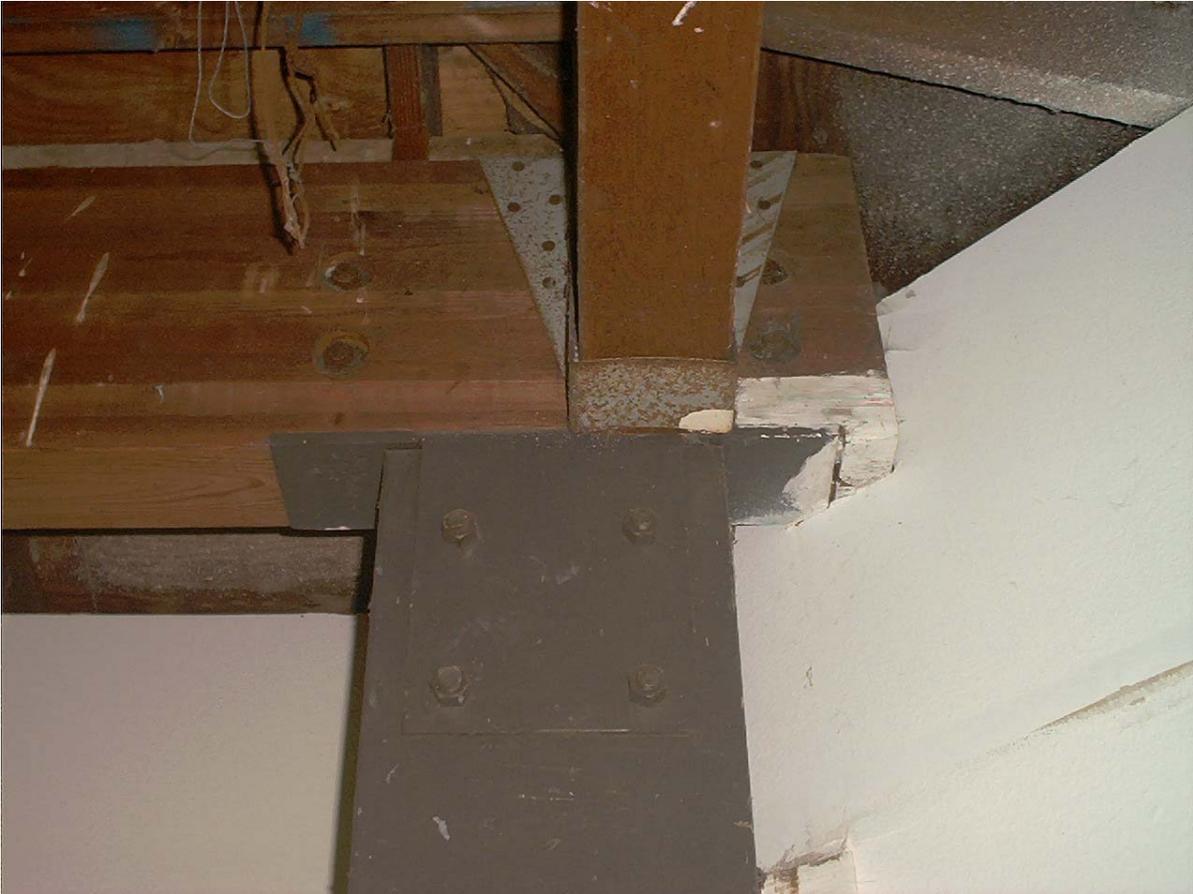
This building was originally constructed in 1979, and remodeled at least once since then. It has two-wythe brick walls to approximately 7' above the floor, then a cripple wall of wood framing with interior gypboard above. The roof consists of tile on plywood sheathing on wood roof trusses supported on glulam beams and columns. The beams parallel to the east and west walls are connected to the columns with four bolts and an assumed knife plate let into the beam. The beams parallel to the end walls are connected to the other beams with sheet metal saddle hangers. The lateral force resistance must rely upon transfer of force from the columns into the brick walls.

One long side is taken up entirely with the original overhead garage doors. The northern half of the building is currently used to store polymer and three large tanks of sodium hypochlorite. The tanks have a height to diameter ratio approaching 2:1 and show no sign of being anchored. The south half of the building is currently used for two large saddle-mounted water storage tanks. A gas-fired water heater is strapped to the south wall. A ceiling-hung gas-fired unit heater is well braced in the east-west direction, but the only restraint in the north-south direction which was observed is the gas piping itself.
